The influence of the physical environment on self-recovery after disasters in Nepal and the Philippines

S. Sargeant¹, A. Finlayson, T. Dijkstra, B. Flinn, H. Schofield, L. Miranda Morel, J. Twigg, E. Lovell, V. Stephenson and B. R. Adhikari

Abstract

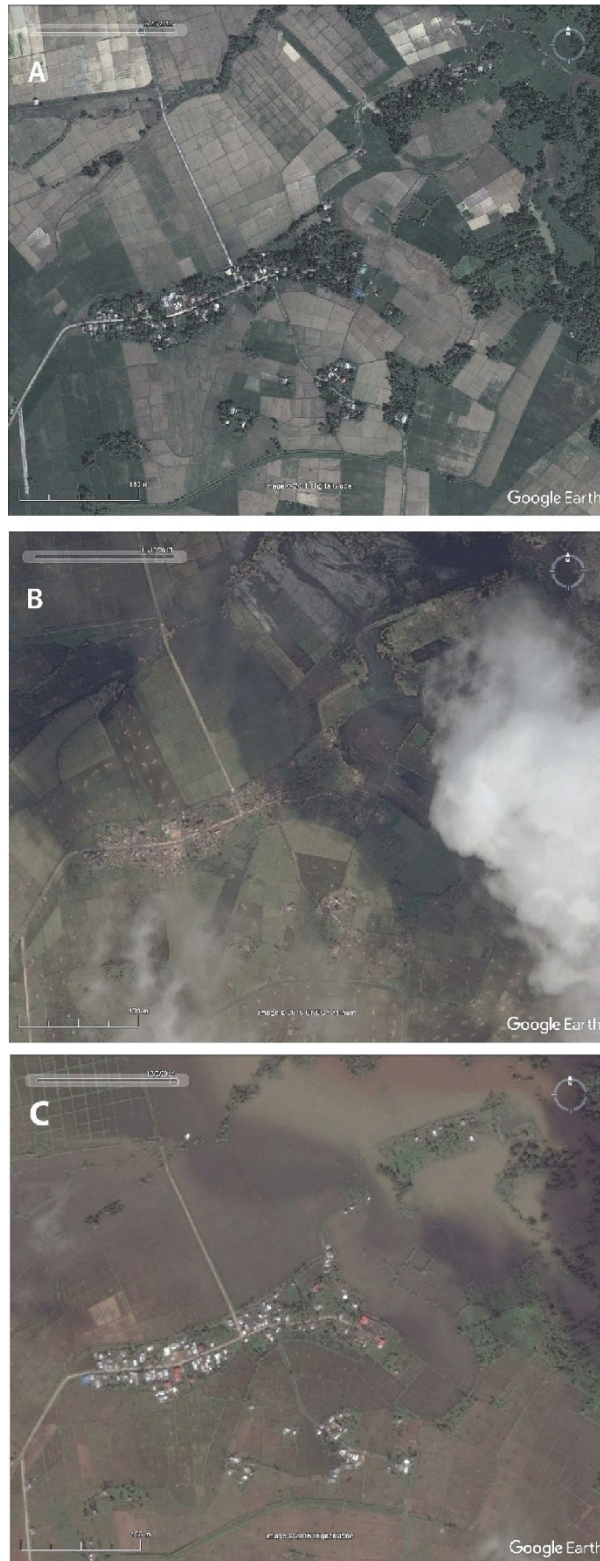
Figure 2. (A) DigitalGlobe image (23 February 2012) courtesy of Google Earth showing the community of Badiangay prior to Typhoon Haiyan. (B) CNES/Airbus image (13 November 2013) courtesy of Google Earth showing the severe wind damage to the community five days after Typhoon Haiyan passed through. (C) DigitalGlobe image (9 December 2014) courtesy of Google Earth, showing the extent of flooding around reconstructed houses following heavy rainfall associated with Typhoon Hagupit. British Geological Survey (c) UKRI 2020.

The primary cause of damage in this community during Typhoon Haiyan was the intense wind speeds that destroyed 125 out of 128 houses (Fig. 2A, B). Flooding also impacted the community, with residents reporting that water levels reached “*knee to waist depth*”. Flooding was a common theme in the focus group discussion about recovery, as might be expected in a community located within the floodplain landsystem: “*we experience flooding every year... water can stay high for several days*”. The extent of flooding during Typhoon Hagupit (associated with lower wind speeds than Typhoon Haiyan, but high total rainfall), which occurred one year after Typhoon Haiyan, illustrates this kind of impact on the community (Fig. 2C). Repeated flooding causes rot and termite infestation, both of which increase the vulnerability of wooden housing.

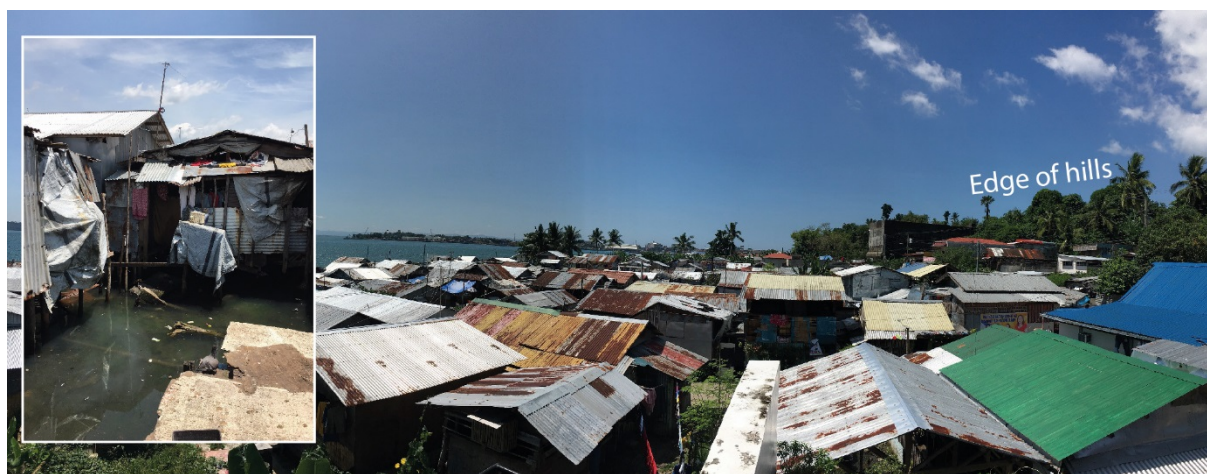
Figure 3. Photograph illustrating context for the community of Anibong, Tacloban. Closely spaced houses are located between the sea and a group of outlying hills. Inset: Shelters encroaching into the sea and are vulnerable to frequent low severity tidal flooding. British Geological Survey (c) UKRI 2020.

outlying hills with slopes up to 30° (composed of weathered sedimentary rocks) all occur in very close proximity (Fig. 3). As a result, a number of shelters encroach out into the sea. At the opposite, south-eastern side of Tacloban City, the barangay of San Juan (Brgy 88) is located on a coastal sand spit where the ground surface rarely rises above a few meters above sea level, and everywhere is within 500 m of the coastline. Both Anibong and San Juan are located in areas where published maps indicate a high storm surge hazard level – and are now classified as no-dwelling zones (Ong et al., 2016; NOAA, 2018). Anibong also includes areas exposed to flood hazard from the Mangonbangon River and a landslide hazard from the hills that the community backs onto. Barangay 83-C is located along the banks and close to the mouth of the Burayan River, and is also exposed to river flooding.

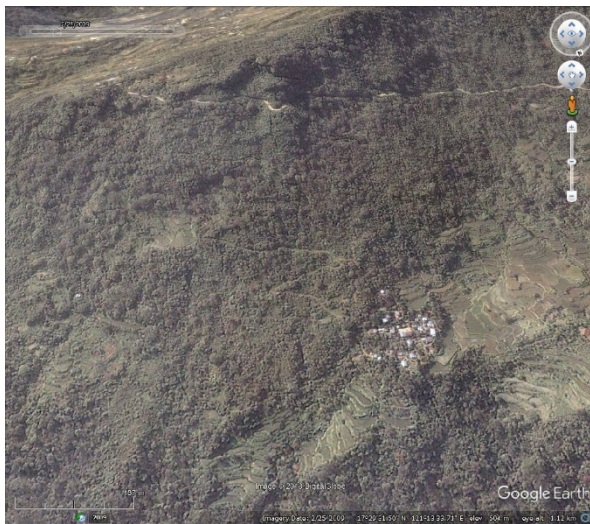
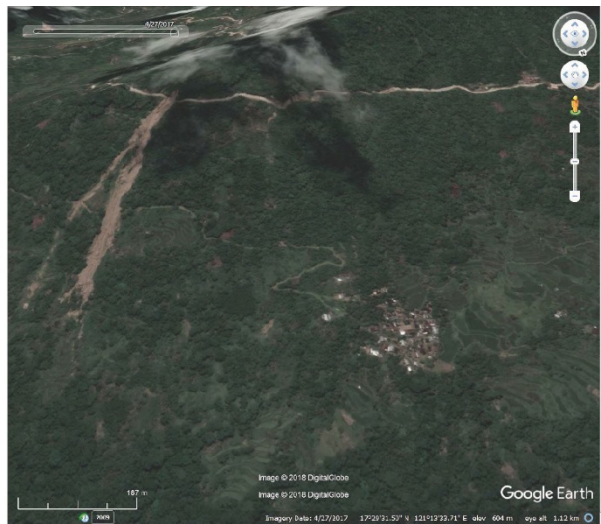
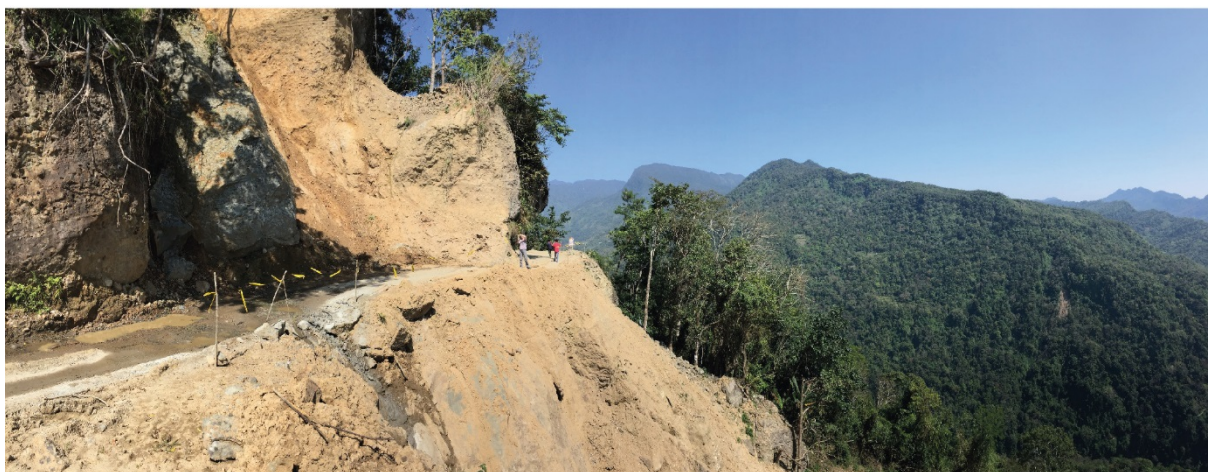
Figure 4. (A) Digital Globe Image (25th February, 2009) courtesy of Google Earth illustrating the context for the community at Sitio Bolo. (B) Digital Globe Image (5th February 2017) courtesy of Google Earth showing the extent of a debris flow adjacent to the community, that was triggered by heavy rainfall during Typhoon Haima. (C) Photograph illustrating conditions on the only access road in March 2017, 6 months after the typhoon. A large landslide scar is clearly evident and unstable blocks remain above the road. Local people spoke of concerns about the continued threat of landslides here. British Geological Survey (c) UKRI 2020.

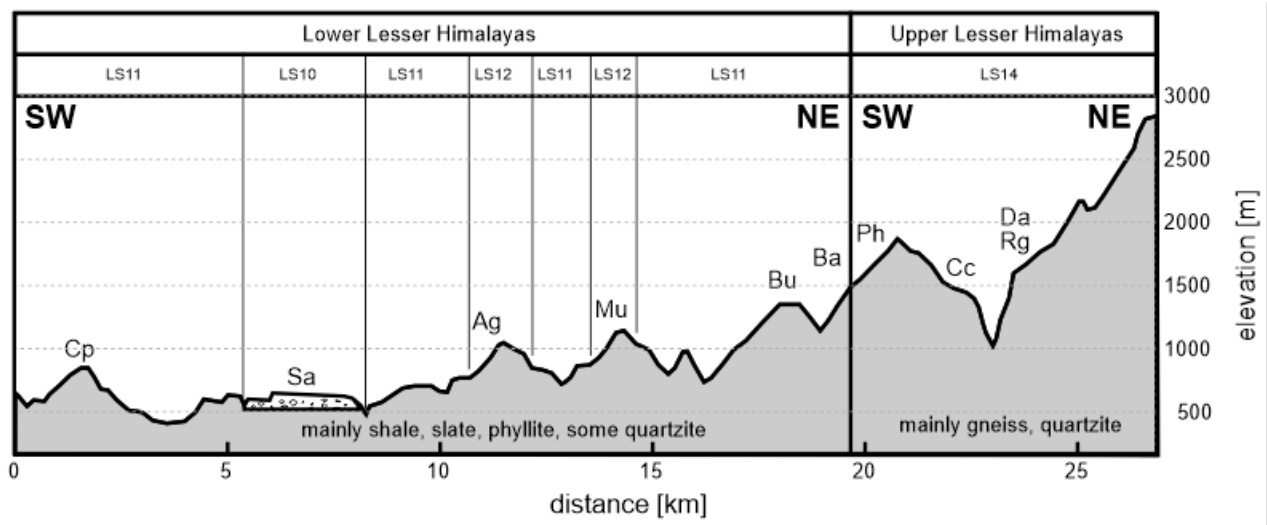
Figure 6. A schematic section through the Lesser Himalayas showing the position of the communities visited in Dhading. Cp – Chainpur; Sa – Salyantar; Ag – Aginchowk; Mu – Mulpani; Bu – Budhatum; Ba – Baseri; Ph – Phulkarka; Cc – Chimchock; Rg – Rigau; Da – Darkha. There is a section offset between Baseri and Phulkarka (see Figure 5). The fill at Salyantar indicates the large terrace comprising ancient sediments of substantial thickness. See also Table 2 for a description of the landsystems (LS10, 11, 12, 14; cf. Carson et al., 1986 in Dijkshoorn and Huting, 2009).

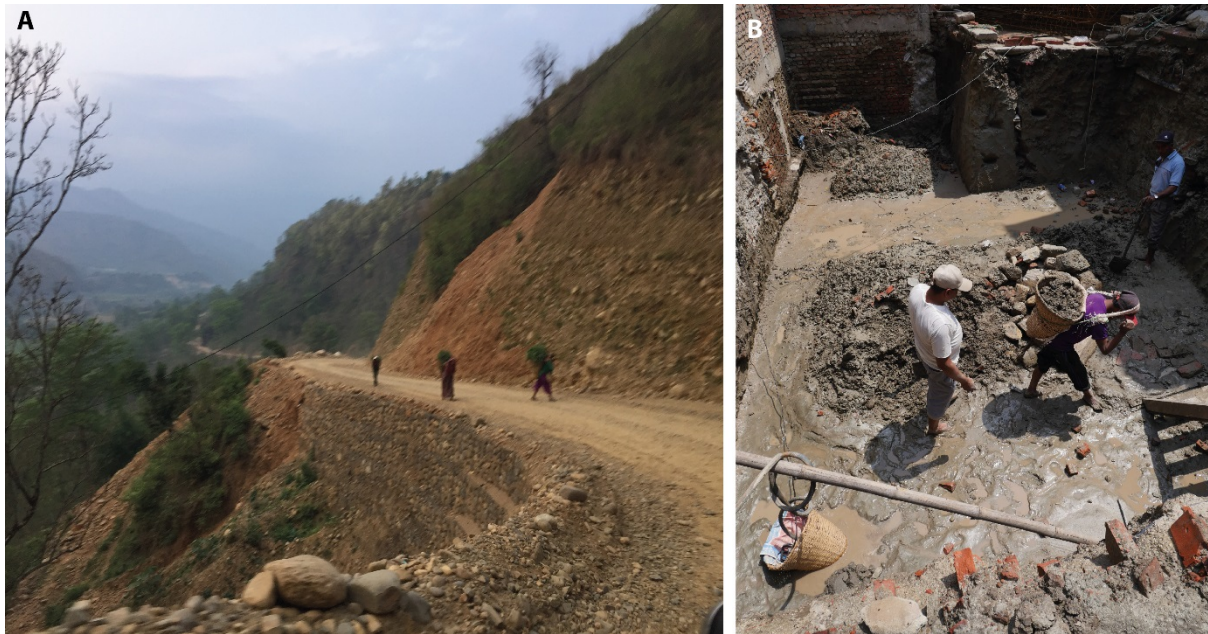
Figure 7. (A) The road that accesses communities on the Salyantar terrace is cut into a steep escarpment that is vulnerable to instability during monsoon rains. (B) Excavation in silts and fine sands with a sump pump, for building foundations in Bhaktapur in April 2018. Evidence for liquefaction below the feet of the construction workers. Local people reported that this stage of reconstruction is not possible during the monsoon.

The clayey and silty nature of the sediments under Bhaktapur make foundation excavation particularly challenging in wet conditions (Fig 7B). Another interviewee in Bhaktapur also described how the occurrence of dry spells can have an impact on rebuilding when mixing mortar: *“Water is scarce here but it is important for the building”* and people had to buy water from tankers to use in housing reconstruction, which increased the cost of rebuilding. The limited weather-controlled ‘windows’ for different building stages compounded delays caused by blocked roads and access difficulties, further slowing down peoples’ recovery.

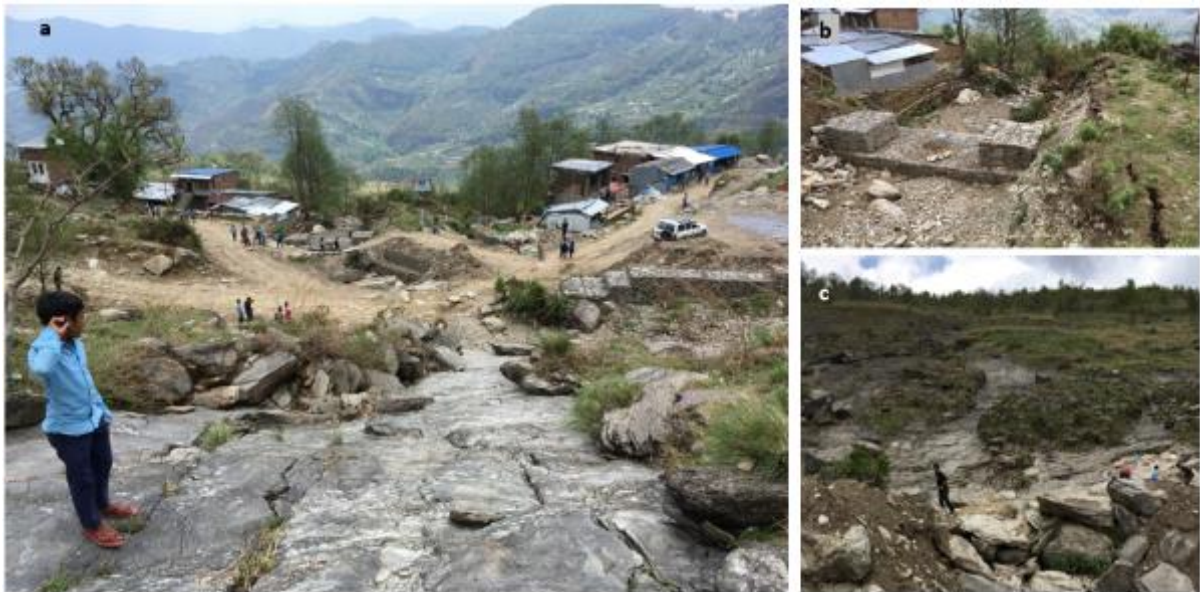
Figure 8. The community of Phulkarka is at risk from high stream flow, overland flow and landsliding. (A) The slopes above the community are widely stripped of their soil cover and this results in very rapid and destructive floods during the monsoon. A system of gabions is being constructed to direct flows and reduce their erosion potential. (B) A close-up of a gabion structure intended to control flow in a stream channel. Bank stability is still very poor (large cracks are visible) and housing is in very close proximity to the stream channel. (C) an view of the slopes above the community highlights the absence of suitable slope and vegetation cover. It is reported that the treeline visible to the left were planted by the community in an attempt to stabilise a landslide.

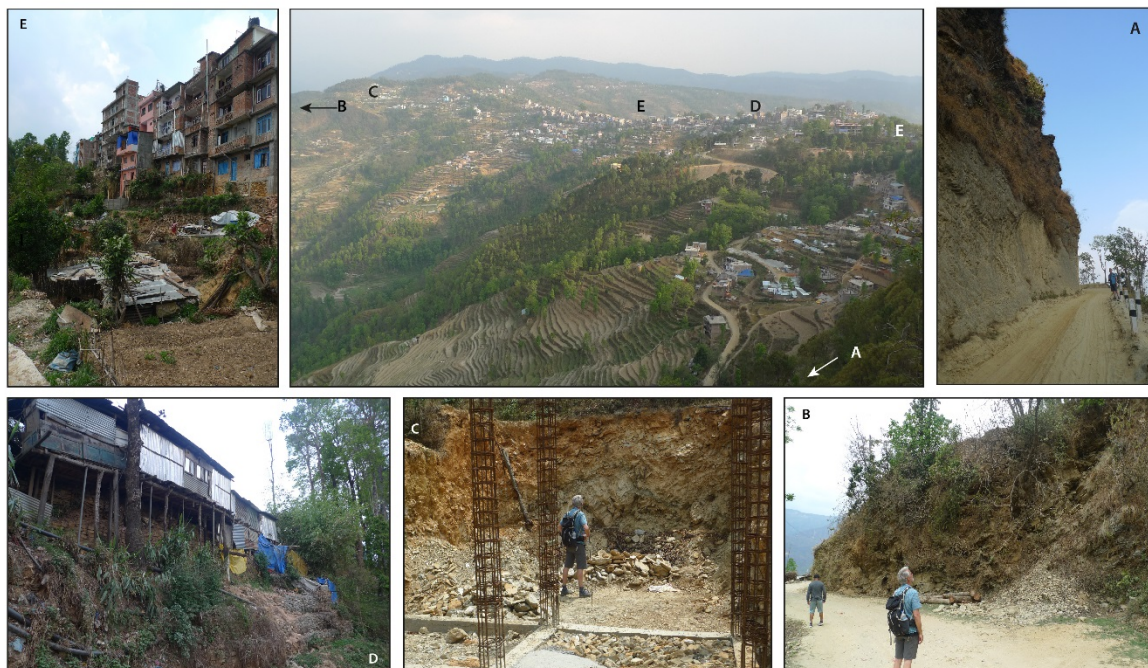
Figure 9. Central image provides a context for the ridge-top urbanised community of Chautara. (A) Vulnerable and exposed access road beneath a steep rock wall to the north of the town. (B) An active landslide at the southern edge of the town. Local people reported that the large block moves every monsoon and impacts the road. (C) Conditions for excavating foundations are challenging. The surface material comprises weathered and fractured bedrock, and has been affected by slope movement. (D) Informal housing at a slope edge, illustrating the challenges of building where flat space is limited. (E) There is a lack of flat building space at the town edge and buildings are constructed several storeys high at the slope edge. British Geological Survey (c) UKRI 2020.

The urban context of Chautara has also led to a shortage of space for building, so that people are increasingly having to build on or close to steeper slopes (Fig. 9D, E). The highly fractured and, in places, weathered nature of the bedrock in Chautara (Fig. 9C) was also reported to be challenge for people digging foundations for their reconstructed homes:
