Example 1. This small waterway on a dairy farm is typical of many agricultural drains in lowland Canterbury, with steep and eroding banks, nuisance aquatic weeds, and poor water quality. These photos show the series of restoration tools that were applied to address these issues and help improve waterway health.

Example 2. This small waterway is on a cropping and sheep farm with multiple waterways within its boundaries. These photos show the series of restoration tools that were applied to address steep collapsing banks that were contributing sediments to the waterway and compromising irrigator bridges. Several sections of the waterway had thick beds of aquatic weeds that were causing blockages and flooding.

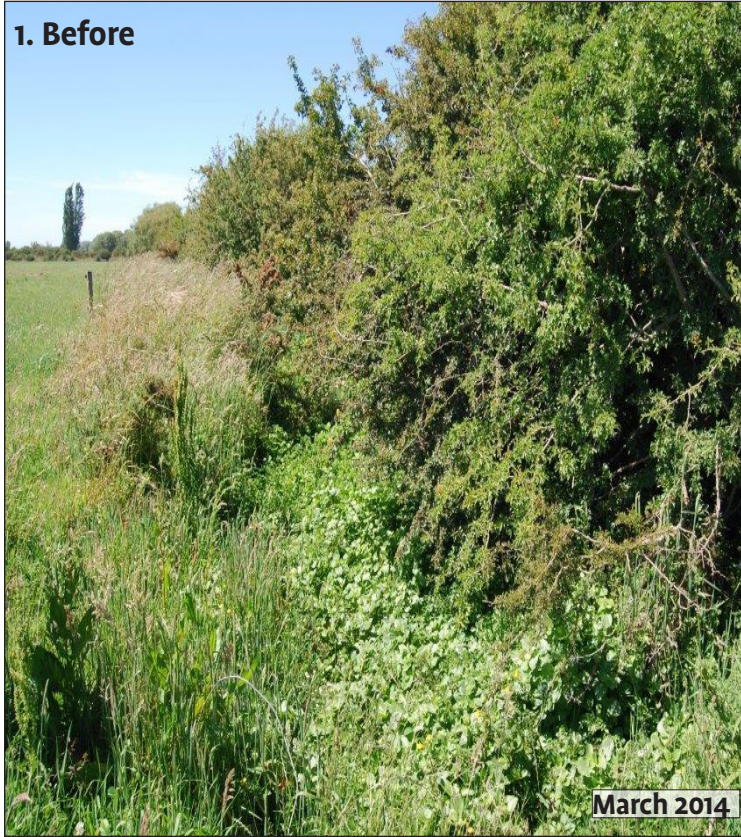
1. Before

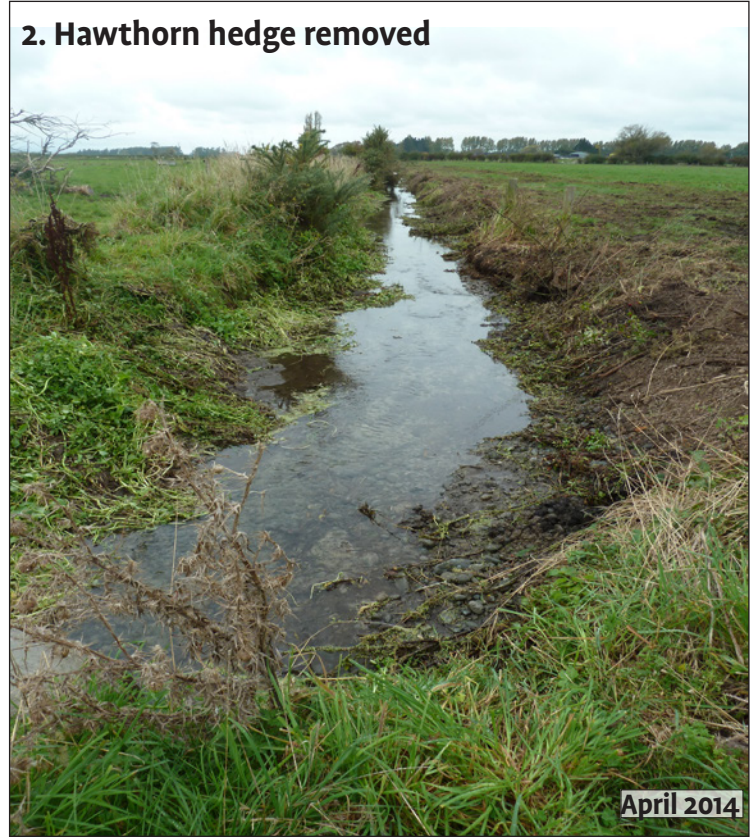
2. Hawthorn hedge removed

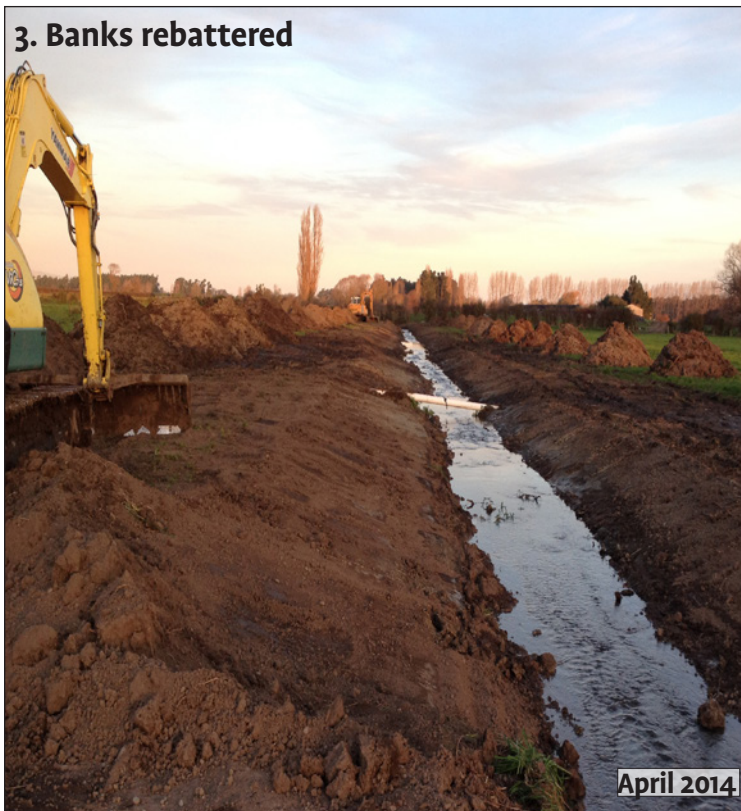
3. Banks rebattered

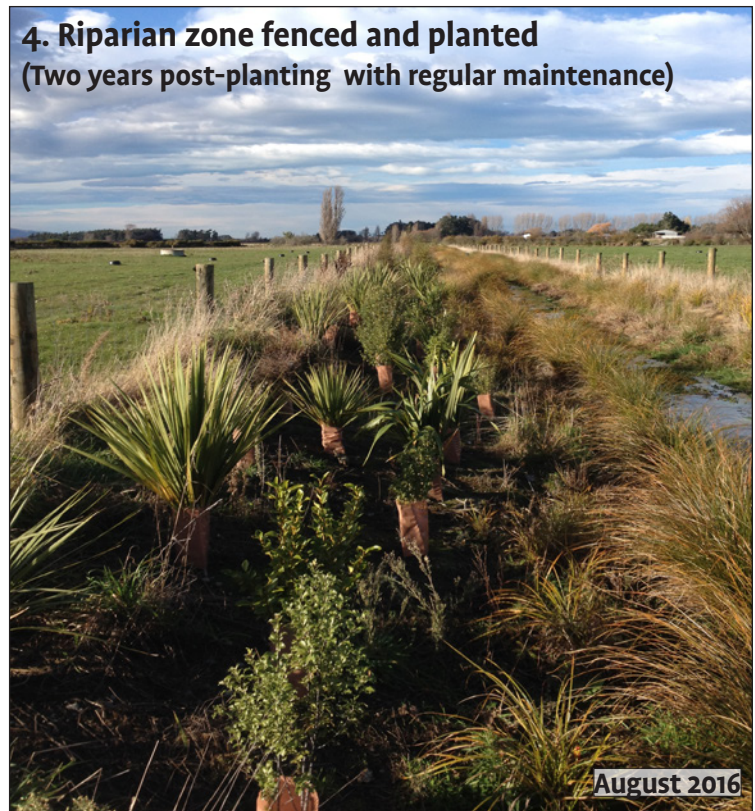
4. Riparian zone fenced and planted
(Two years post-planting with regular maintenance)

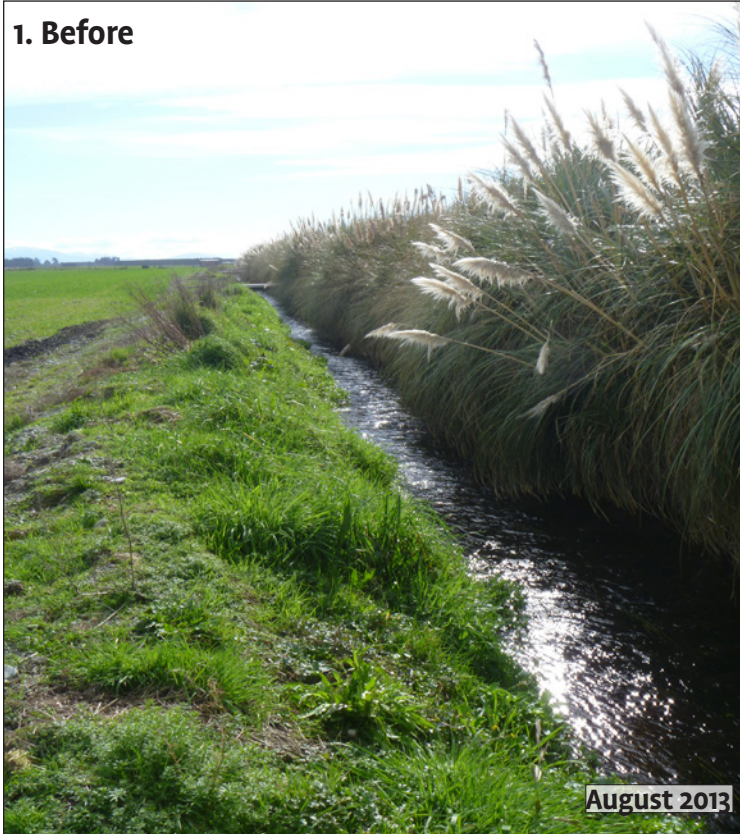
1. Before

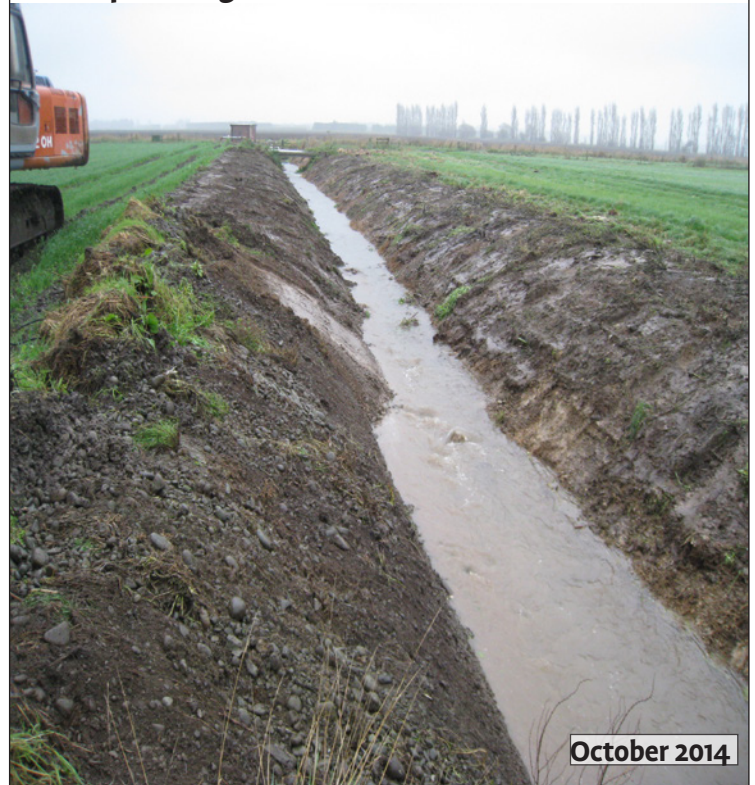
2. Pampas hedge removed and banks rebattered

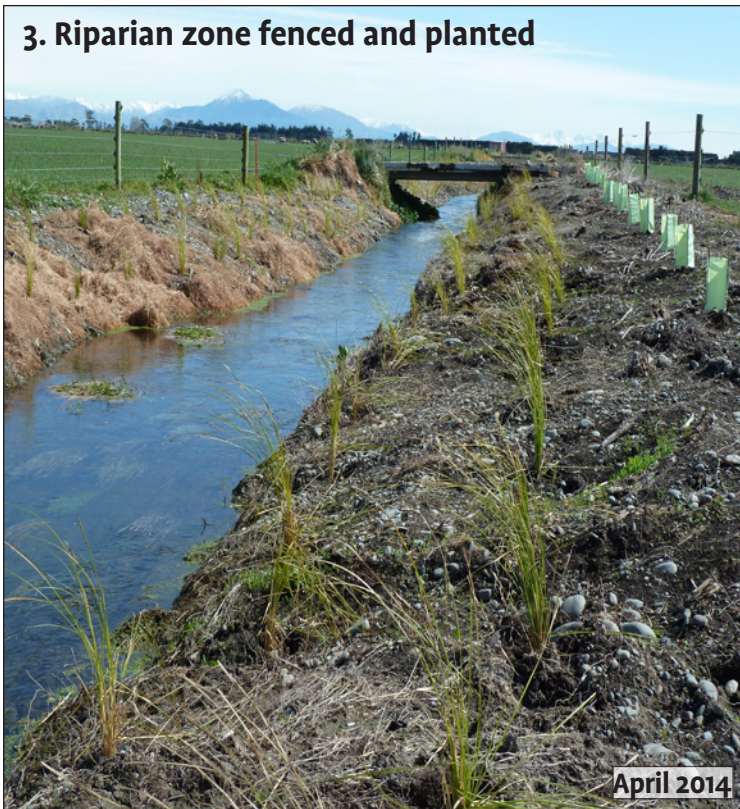
3. Riparian zone fenced and planted

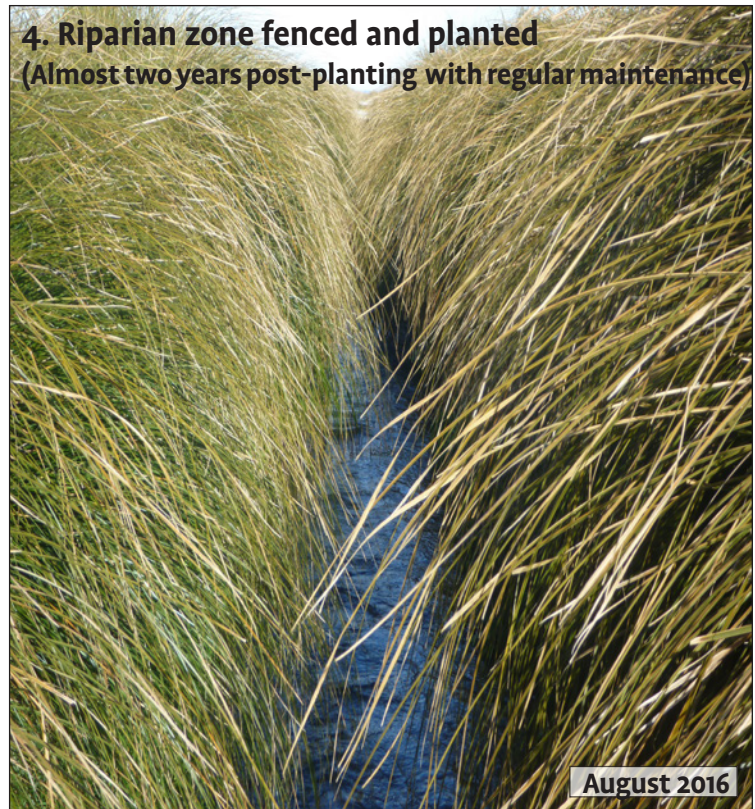
4. Riparian zone fenced and planted
(Almost two years post-planting with regular maintenance)
