MARS ultra-high-resolution imaging for improved characterisation of pre- and post-operative scaphoid fractures

CASE STUDY

Purpose of the study: To evaluate the diagnostic potential of MARS spectral photon-counting CT in the quantitative and qualitative assessment of scaphoid fractures.

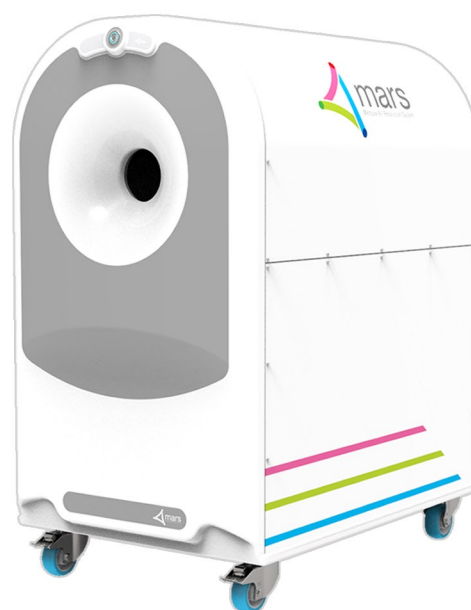
Image of the upcoming MARS arm scanner is indicative only

MARS uses a low power x-ray tube, photon counting detectors (Medipix3RX) and narrow energy ranges to differentiate and measure multiple materials (lipid, water and calcium) in a single scan. The smaller pixel size of the photon counting detectors (110 μm) enables visualisation and quantification of both cortical and trabecular density, as well as characterising the morphology of the fracture site. The scans are lower dose and can be retrospectively reconstructed in isotropic voxel sizes ranging from 60 μm to 500 μm .

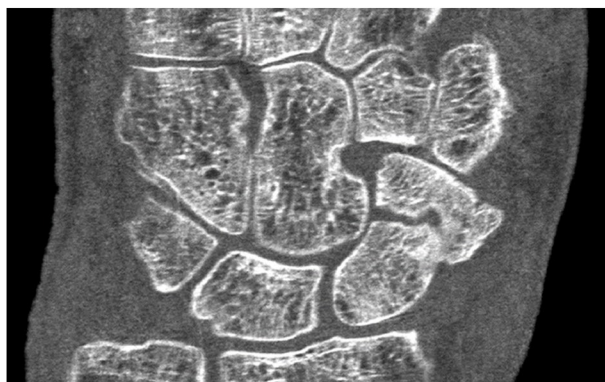
Figure 1: Coronal view of the left wrist showing a comminuted transverse fracture at the scaphoid waist.

Results: The MARS images show a comminuted transverse fracture at the scaphoid waist. Sclerosis was observed at the fracture margin seven months post injury indicating non-union. Sagittal images show collapse at the fracture site with humpback deformity. Proximal pole sclerosis was not observed.

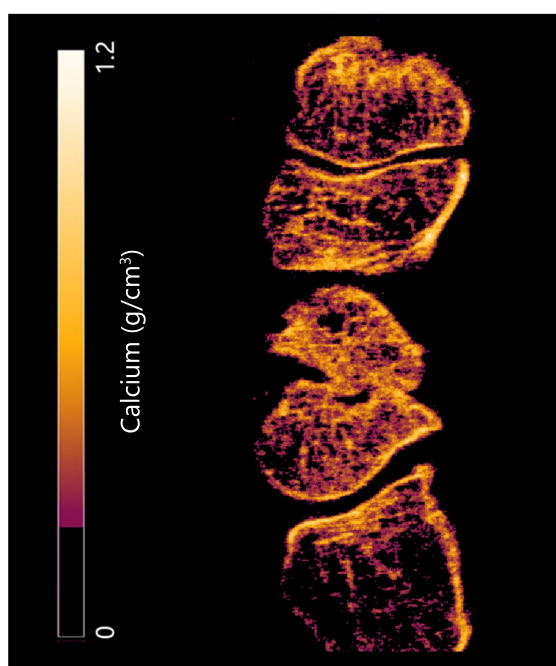
Figure 2: Sagittal calcium imaging demonstrates sclerosis of the scaphoid fracture site and humpback deformity. The colour code represents the density of the calcium.

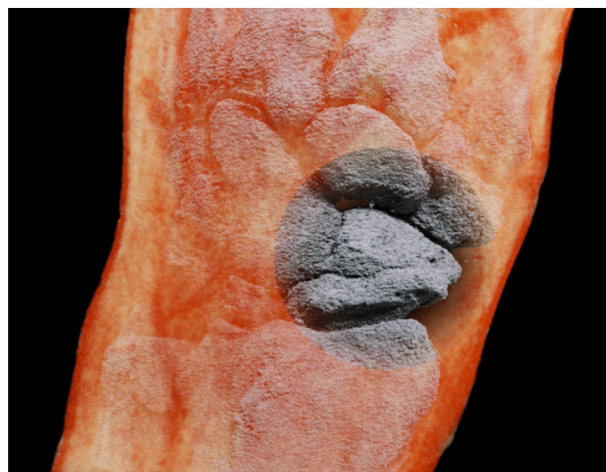
Figure 3: 3D volume rendering of the patient's wrist differentiating soft tissue and bone.

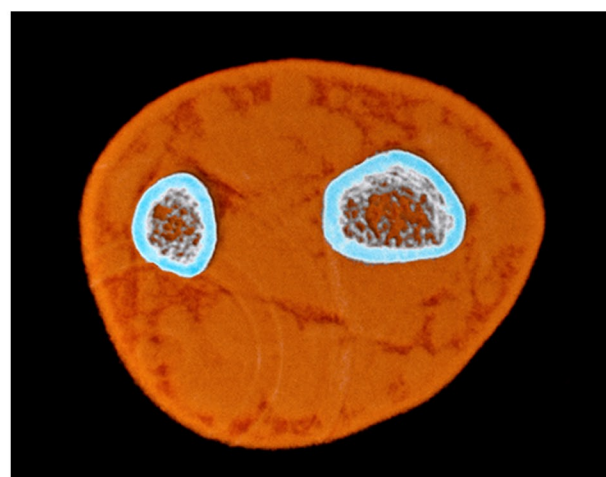
Figure 4: Transverse image of the patient's wrist highlighting bone segmentation.

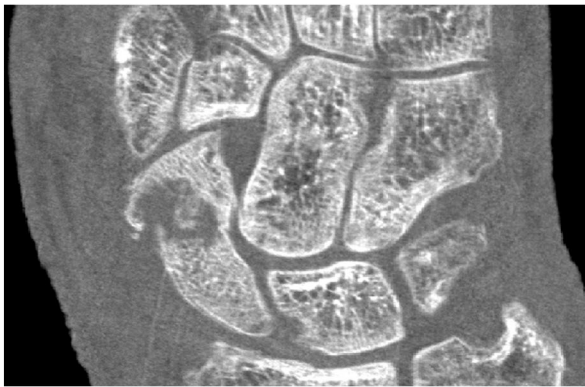
Figure 5: Coronal view of the right wrist demonstrates the separation between the fracture fragments.

Results: The MARS images show non-union with displacement. Small bony fragments were observed at the fracture margin. The separation between the fracture fragments was more than 3 mm. Sclerosis was not observed.

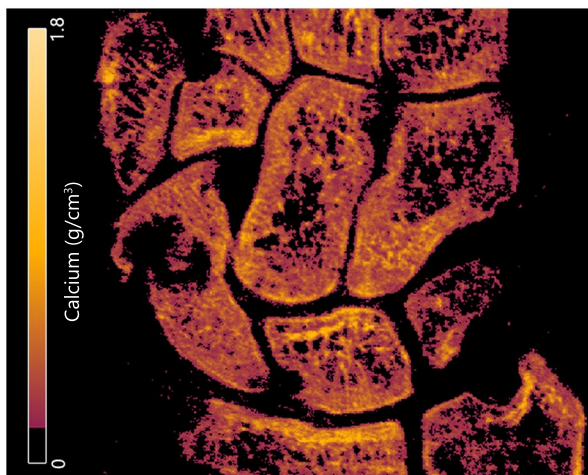
Figure 6: Sclerosis of the fracture margins was not observed on calcium imaging.

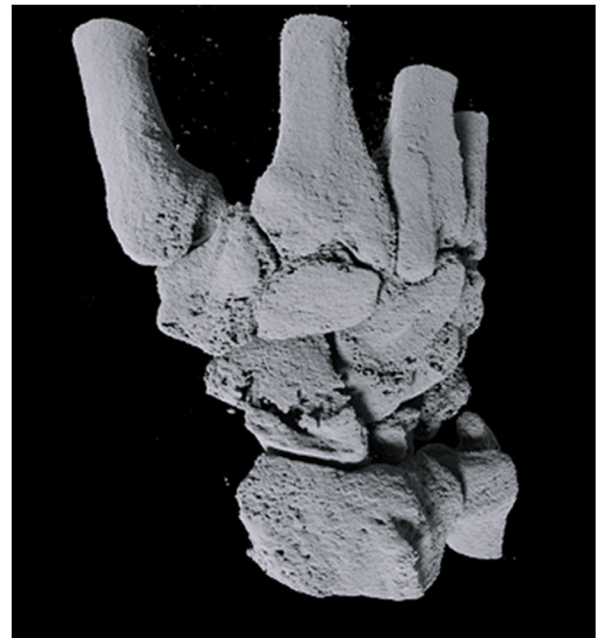
Figure 7: 3D rendering of the calcium imaging of patient's wrist with scaphoid fracture.

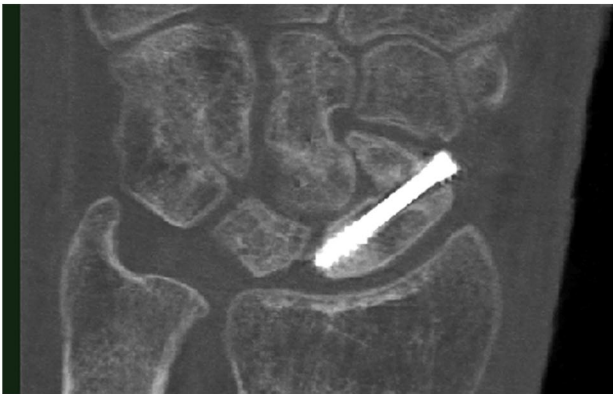
Figure 8: Coronal views of the left wrist show bone and soft tissue in the vicinity of the implant with reduced metal artifacts.

Results: MARS images show reduced metal artifact at the bone-metal interface and visualisation of soft tissue in the vicinity of the implant. The MARS images show the impingement of the screw on the scaphotrapeziotrapezoidal (STT) joint. Sclerosis was observed at the proximal pole of the scaphoid suggesting avascular necrosis.

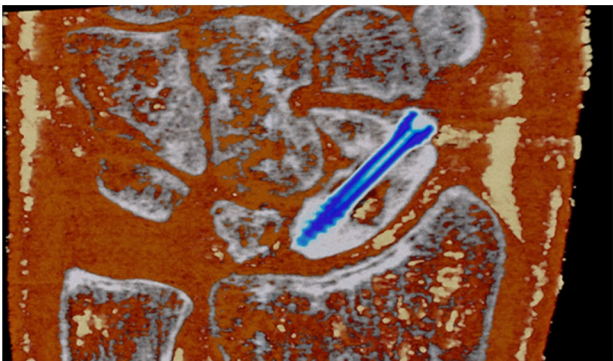
Figure 9: This image demonstrates differentiation of tissues, fat (yellow), soft tissue (orange red), bone (grey), and screw (blue).

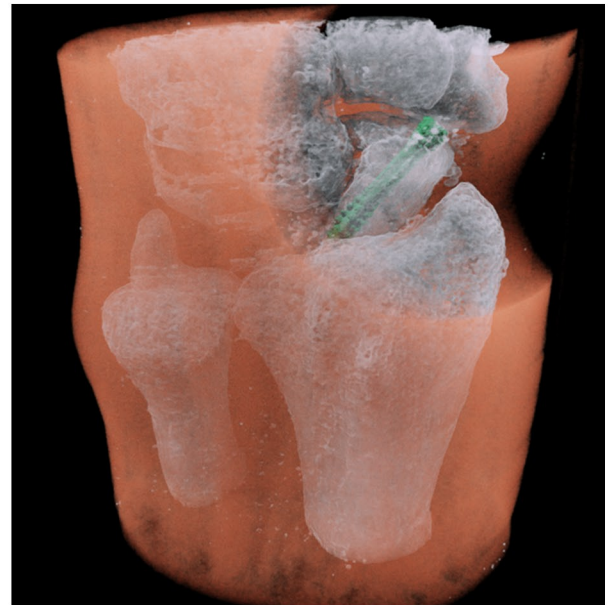
Figure 10: 3D volume rendering of the patient's wrist. The bone has been made slightly translucent to enable better visualisation of the position and orientation of the screw.
